Utilizing NASA Earth Observations to Assess Sea Level Rise and Develop Optimal Green Infrastructure Plans to Restore Mangrove Habitat and Enhance Coastal Resiliency

Maria Luisa Escobar Pardo*, Christopher Cameron, Abhishek Kumar,
Sonia Linton, David Rickless, Navid Hashemi Tonekabon, & Sam Weber

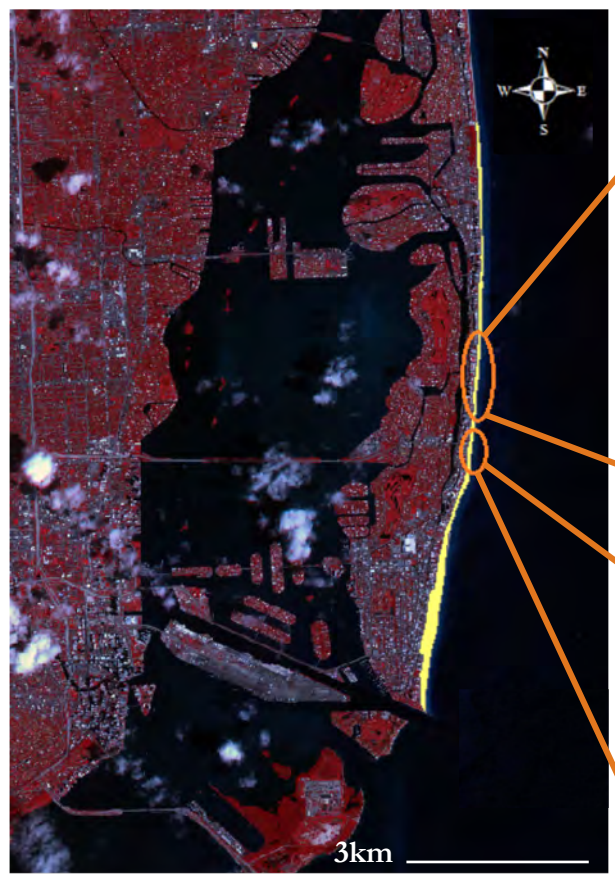
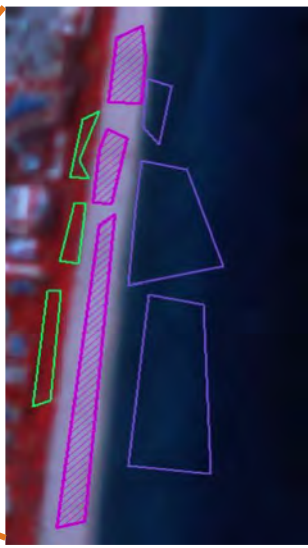
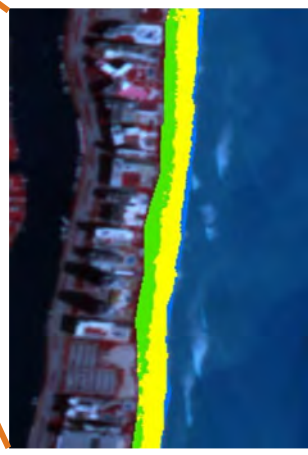
Results – Coastal Damage

Sand
 	 	Vegetation
 	 	Water

Dates	Class	Area (km ²)
09/07 (3 days before Irma)	Sand	0.71
	Vegetation	0.48
09/12 (2 days after Irma)	Sand	0.92
	Vegetation	0.26
10/30 (40 days after Irma)	Sand	0.79
	Vegetation	0.39

- ▶ Approximately **45%** of coastal vegetation along Miami Beach **was lost or damaged**
- ▶ An estimated **26%** of this **vegetation recovered** within 40 days of the storm's passing

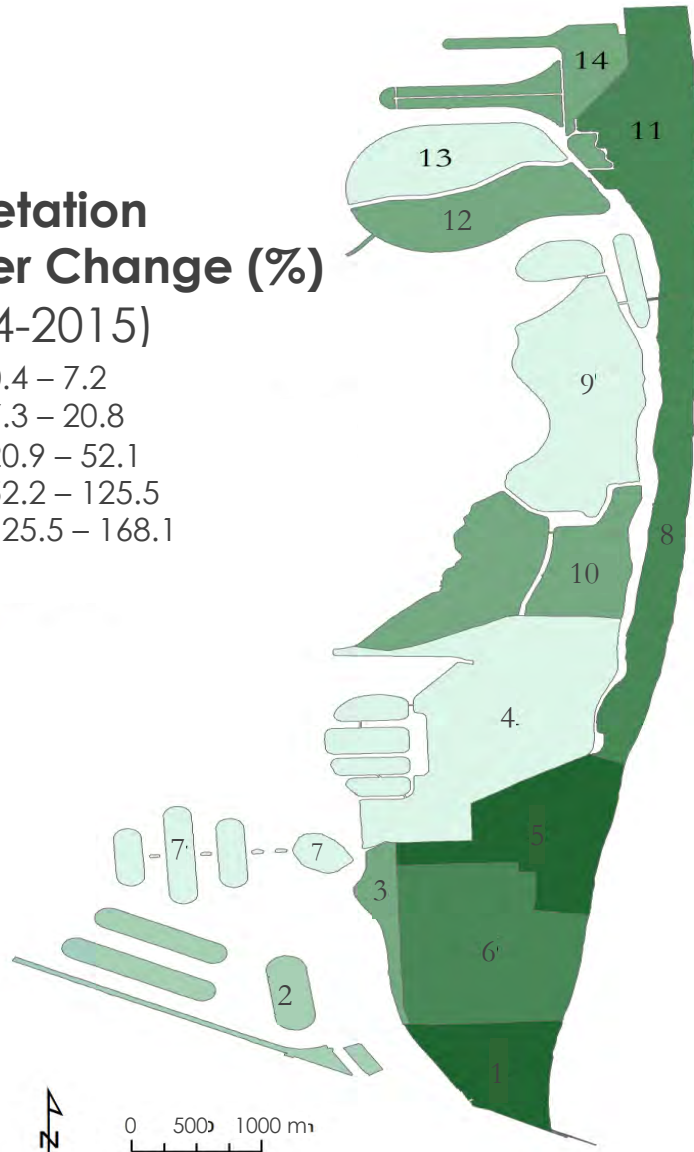
Vegetation Cover Change (%) (1994-2015)

Neighborhoods

1. South Pointe
2. Star/Palm/Hibiscus
3. West Avenue & Bay Road
4. Bayshore
5. City Center
6. Flamingo/Lummus
7. South & Venetian Islands
8. Oceanfront
9. La Gorce
10. Nautilus
11. North Shore
12. Normandy Isles
13. Normandy Shores
14. Biscayne Point

- ▶ The city of Miami Beach saw a **24% increase** in vegetation coverage between 1994 and 2015
- ▶ The city's plans to **implement and maintain green infrastructure** are having positive effects

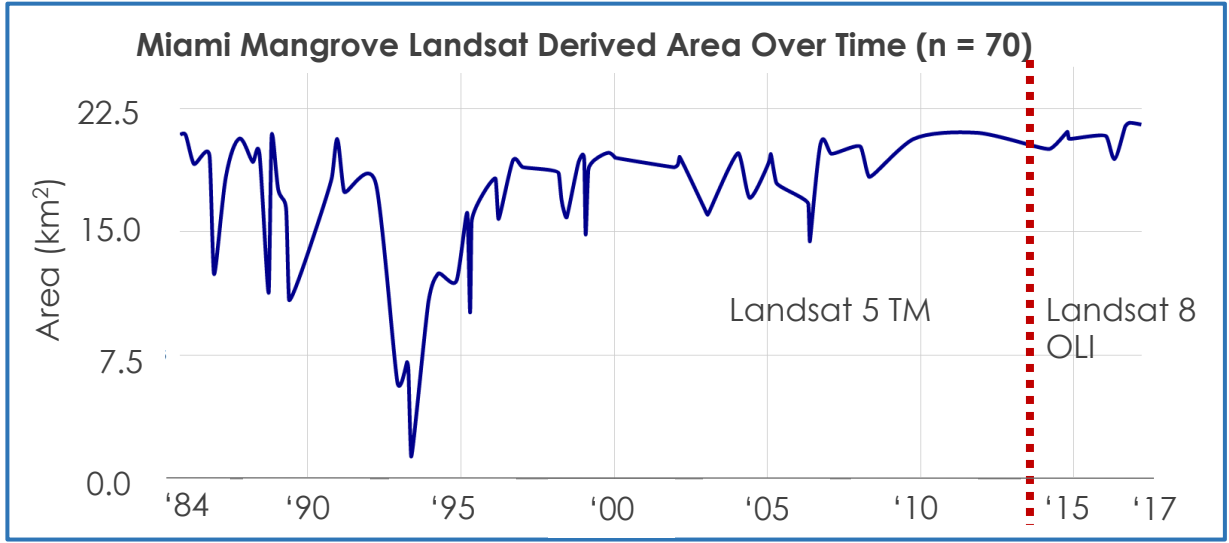
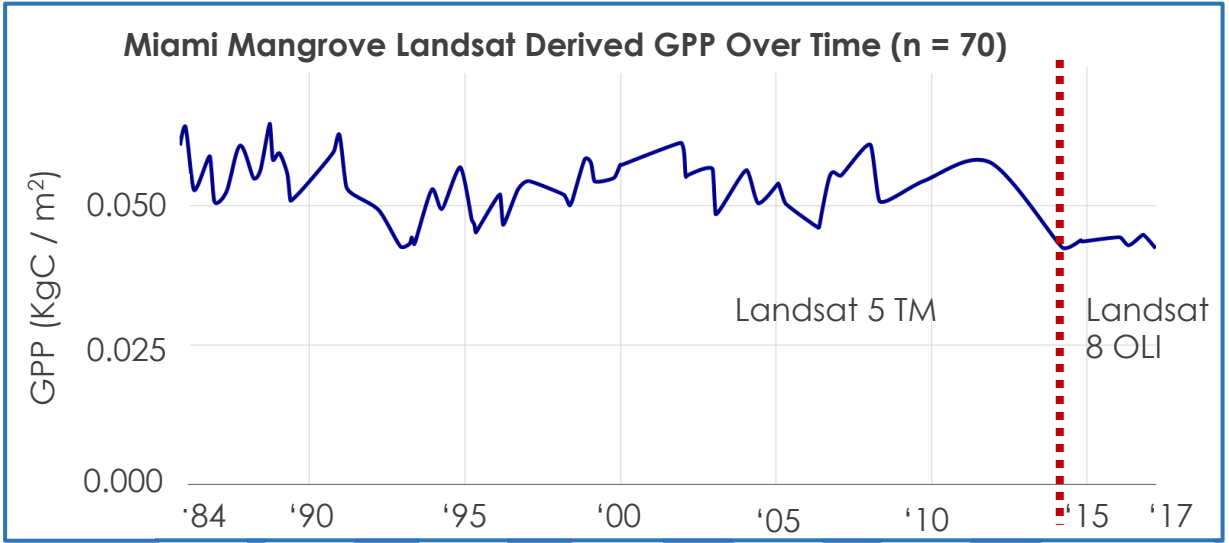
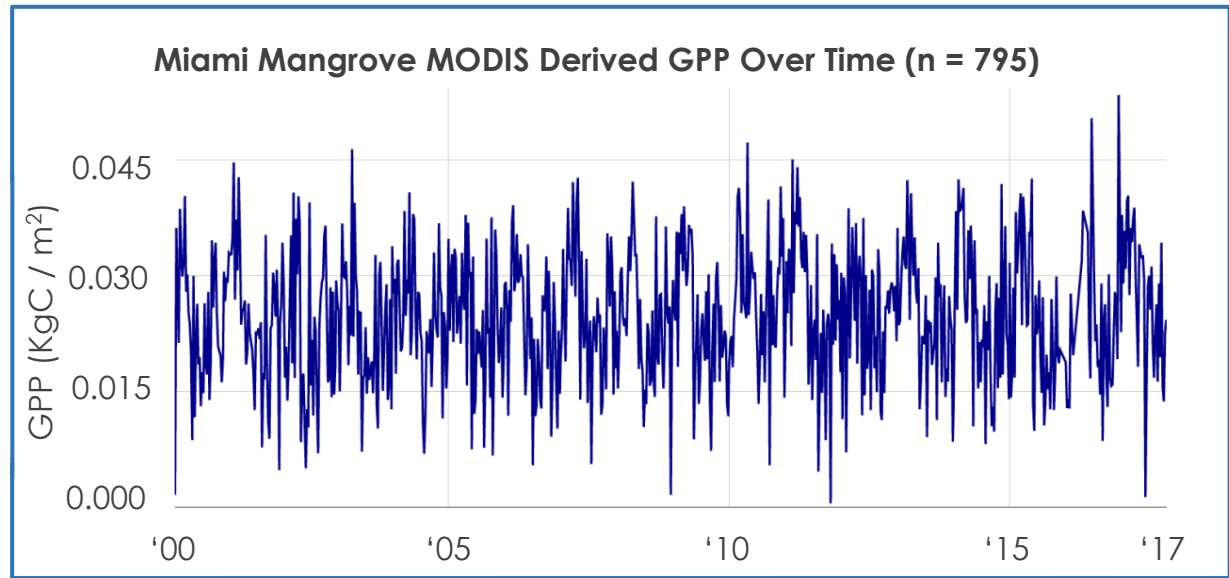
Results – Mangrove Health

$$GPP = 0.096926 * EVI + 0.0003819$$

Where, $EVI = 2.5 [(NIR - Red) / (1 + NIR + 2.4 * Red)]$

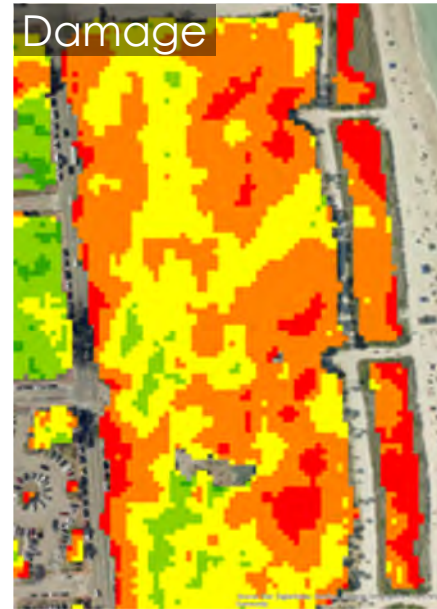
Damage

North Shore Park

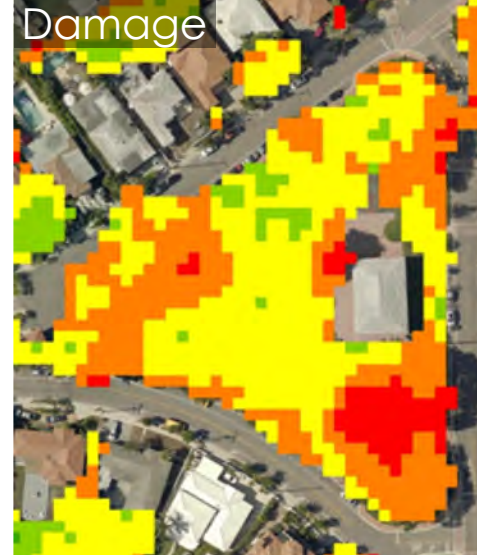
Damage

Still Water Park
